INFO-TECH n. 03/22 – 17/02/2022

we have recently been supplied with a quantity of roller bearings BC1-3342B (p.n.: X30125397 for the X30 engine) where the lateral washer shows a slightly different appearance featuring a small frontal groove as shown in the picture below:

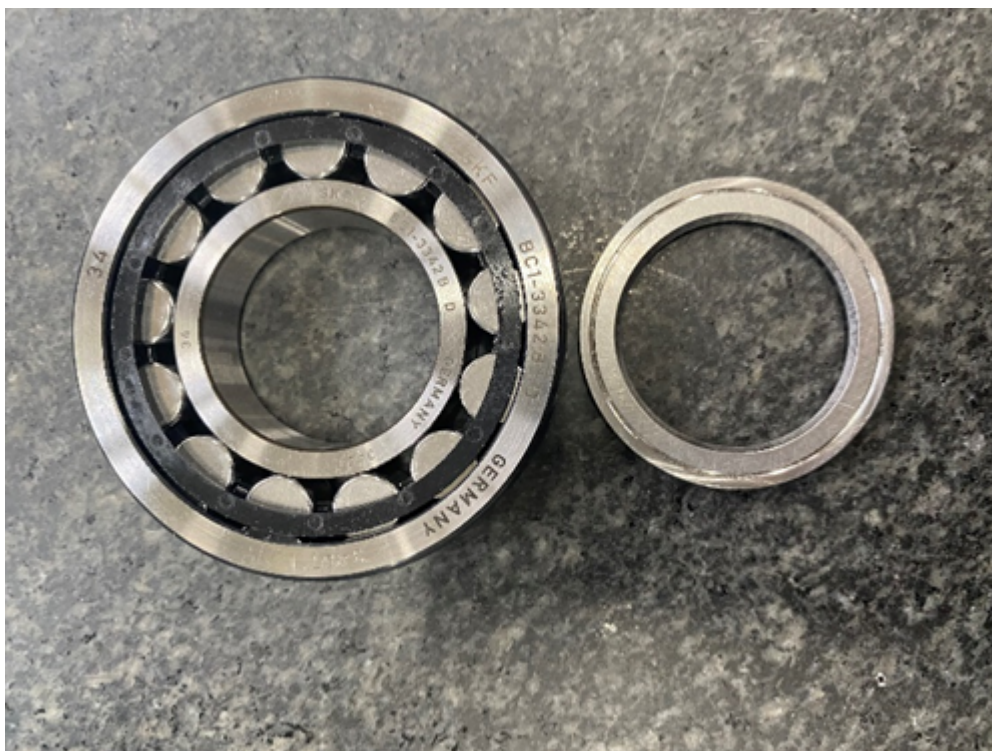
This is just due to the manufacturing process, probably done in a different facility.
Of course the engine integrity and performance are not affected by the a.m. bearings.

We kindly ask you to inform the Federation of your reference, the IAME classes race promoters and edit the class regulations if needed.
